Interstate Technical Group on Abandoned Underground Mines
Sixth Biennial Abandoned Underground Mine Workshop

Update of Abandoned Underground Mine Activities in Ohio

Ohio Department of Transportation
Office of Geotechnical Engineering

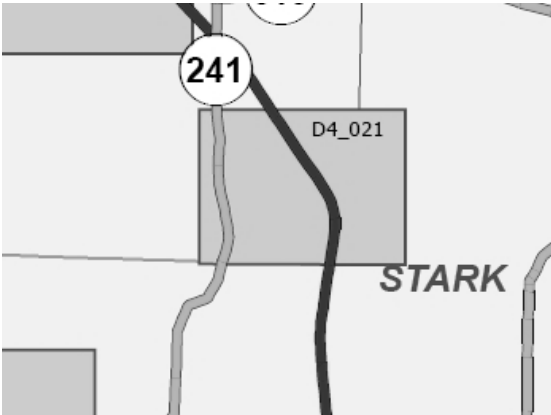
District 4 Mine Scene Index

The District Mine Scene Index provides location and scene numbers

The map displays a mine scene index. A black line, likely a road or boundary, runs diagonally from the top left towards the bottom right. A white circle with the number '241' is positioned on this line. To the right of the line, a gray rectangular area is labeled 'D4_021'. Below this area, the word 'STARK' is written in large, bold, black capital letters. The background is light gray with some faint lines and shapes.

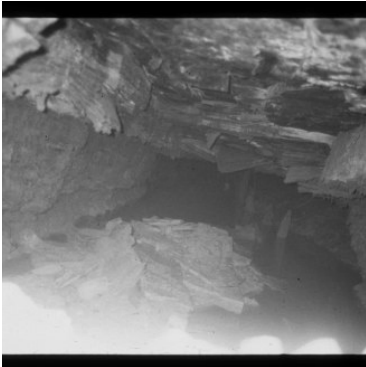
Some mine voids are flooded or partially flooded.

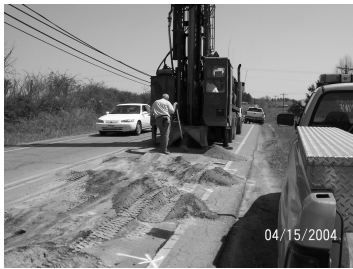
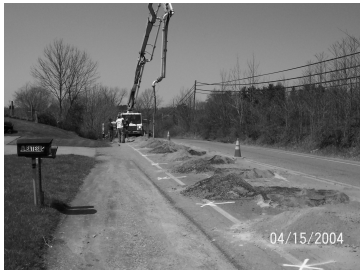
Ohio State Route 93 Emergency Mine Remediation Project

- Perry County
- 2-lane state route
- Response to ODNR AML program reports of coal mine subsidence beyond both sides of the roadway
- No mine maps available
- Project length 450 feet
- Remediation method Drilling and grouting. 162 Cu. Yds. Class C concrete placed
- Project Cost: Approx. \$23, 000

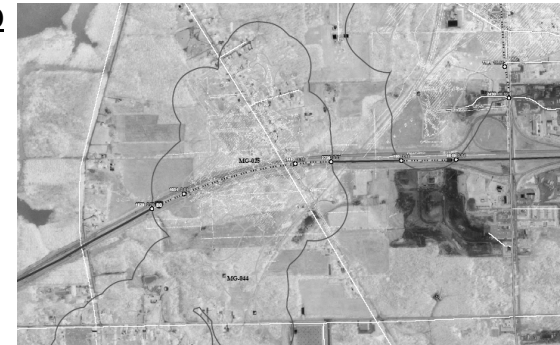
Interstate 80

- Major New Project to add lanes and remediate mines
- Mahoning County Limited Assess Connector
- Mine remediation included drilling and grouting mapped and unmapped abandoned underground mine voids.
- Approximate cost of mine remediation Construction: \$1.5 million

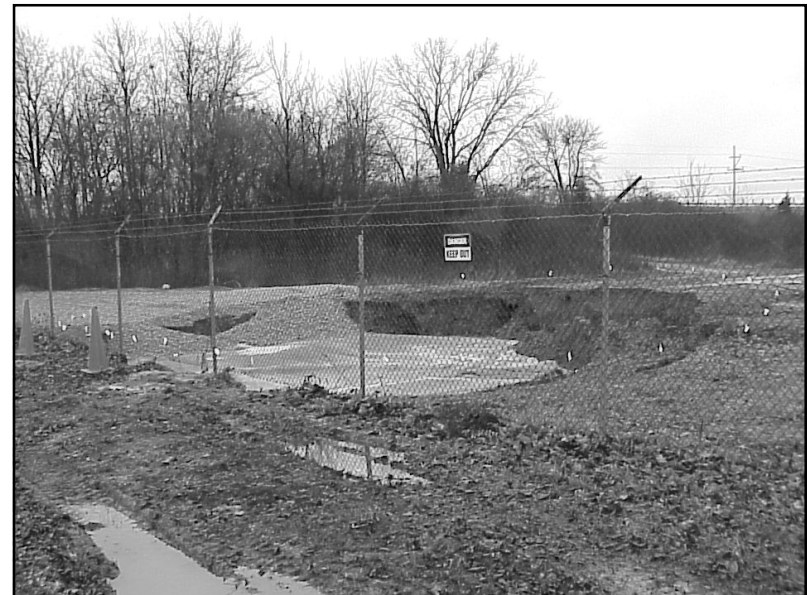
U.S. Route 33 (Nelsonville, Ohio By-Pass)

- Hocking and Athens Counties
- 9 mile new alignment
- Numerous Abandoned Underground Mines and Abandoned Surface Mines
- Construction to Begin in 2007
- Estimated cost of Construction = \$190 Million, including an estimated \$25 to \$50 Million for abandoned mine remediation
